# TOXIC MINE SITE IN LODE NEEDS FIX

*Water leaking into landfill at heart of '90s cleanup*

## Still toxic

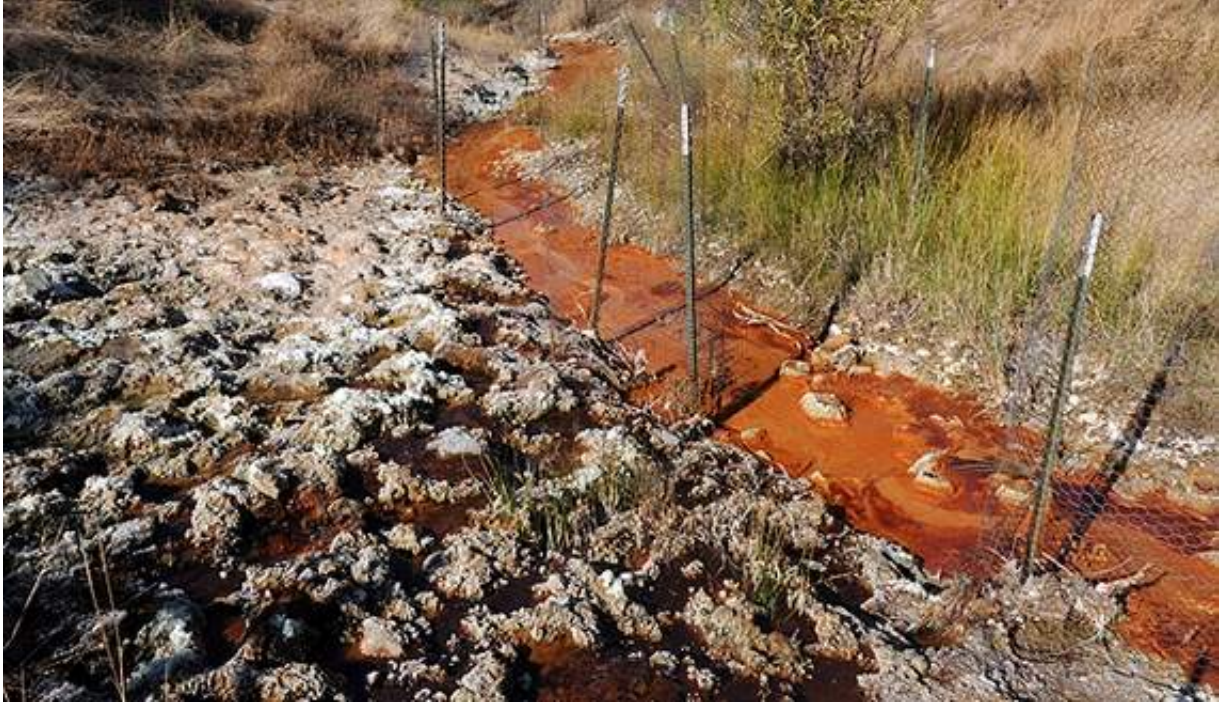
Crusty mineral formations cover rocks next to a creek flowing with discolored water below a landfill where 350,000 cubic yards of waste from a former mine are stored near Camanche Reservoir.

But there's still plenty of evidence of the mine's toxic past, including crusty mineral formations along creeks and bright red and orange water trickling down the gulch that leads from the place where 350,000 cubic yards of waste from the former copper and zinc mine lie buried in a landfill.

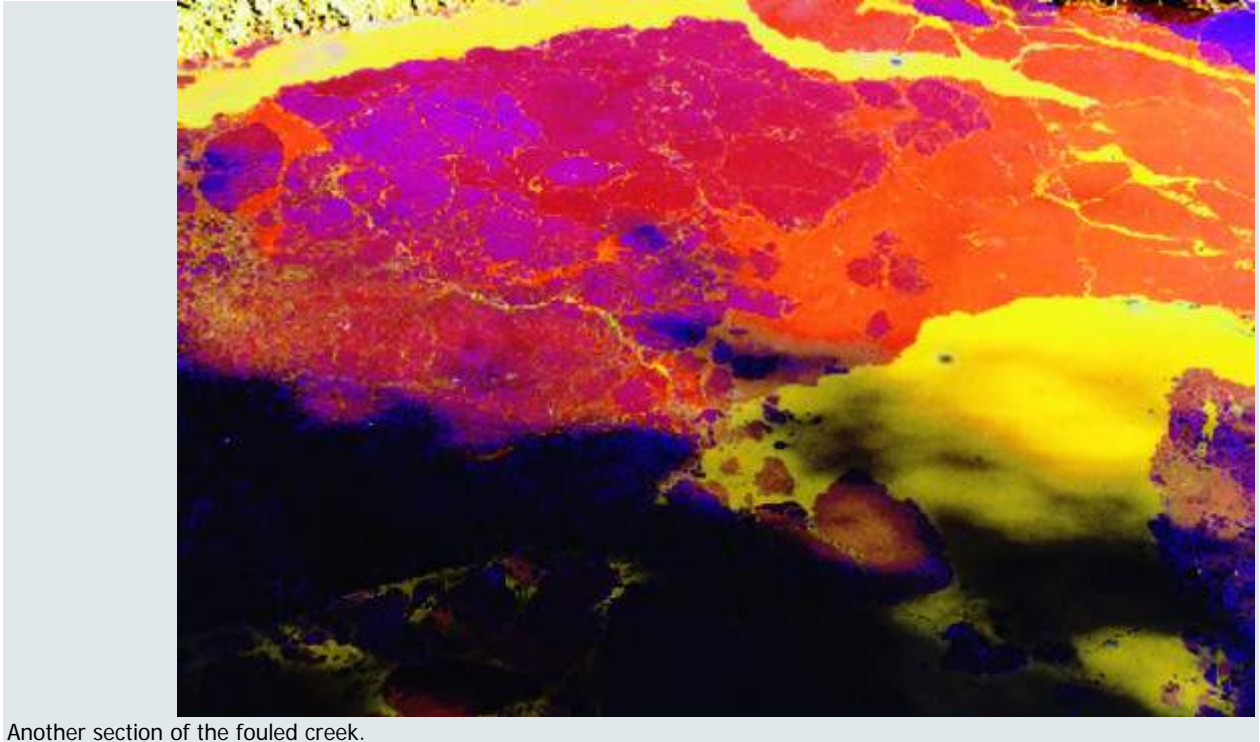
Another section of the fouled creek.

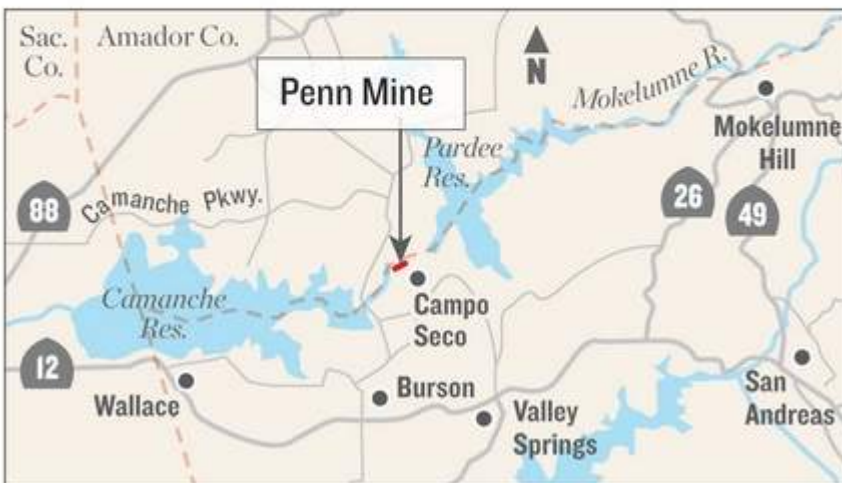
The Penn Mine, one of the largest hazardous waste cleanups in California history, is still leaking more toxic water than expected, state water pollution regulators say. A \$1.2 million repair to seal water outside of the landfill holding the mine's tailings will be conducted this fall.

The landfill site looks like a grassy hilltop surrounded by a barbed-wire-topped chain link fence. Beneath the grass and a layer of soil is a heavy-duty plastic geomembrane similar to that used to line municipal dumps.

The top geomembrane layer simply overlaps the plastic membrane that covers the side of the landfill, much like the folding closure used in old-fashioned plastic sandwich bags.

The repairs to be done this fall will require digging up the overlapped geomembranes and bonding them together so it won't be possible for water to leak through. Shaw will do that work and will also rebuild a system of V-shaped drains around the edge of the top of the landfill.
